TWR- 17541 Vol. VII  
ECS #: SS 01010

Flight Set 360L002 (STS-27)  
Field Joint Protection System Final Report  
Volume 7

June 1989

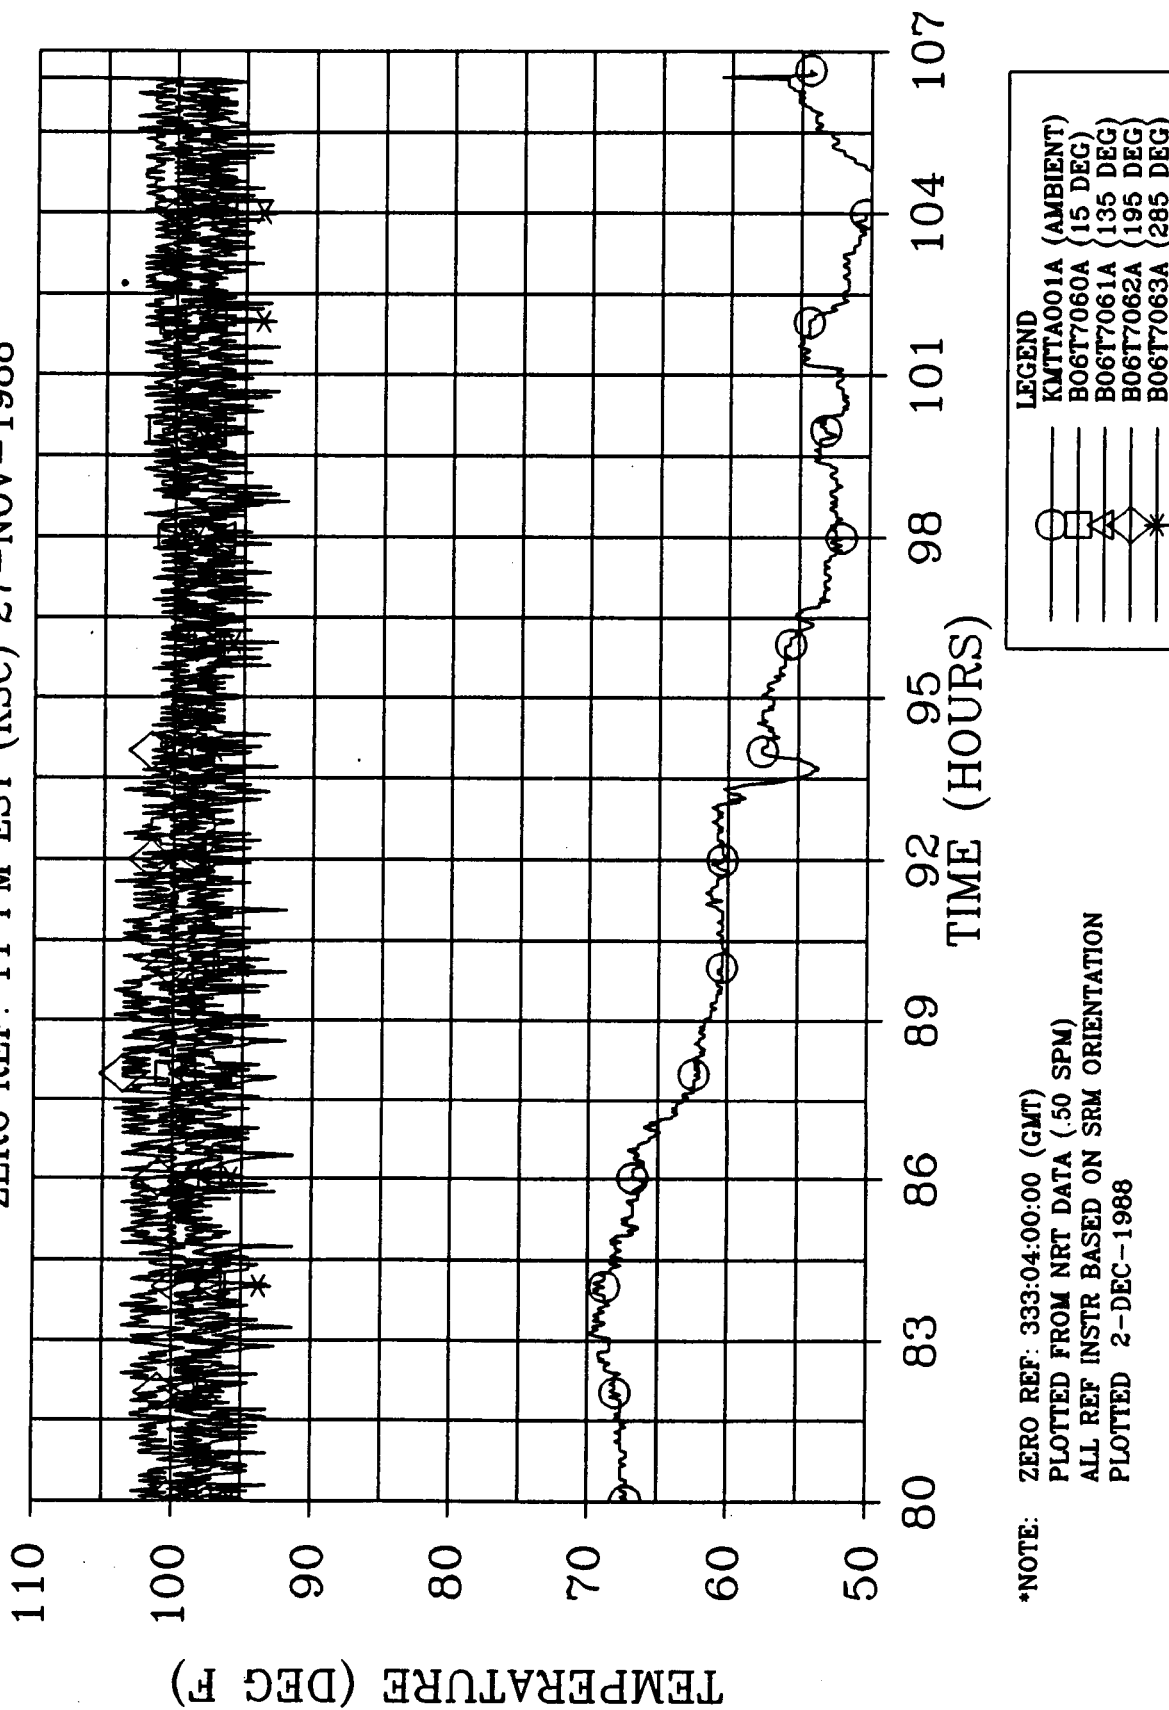
Figure 4

Figures 4 through 6 are plots of the temperature of the four RTD's of each of the three field joints of the left SRM and figures 7 through 9 are plot of the RTD's of the right SRM. The ambient temperature is overlaid on the temperature plots.

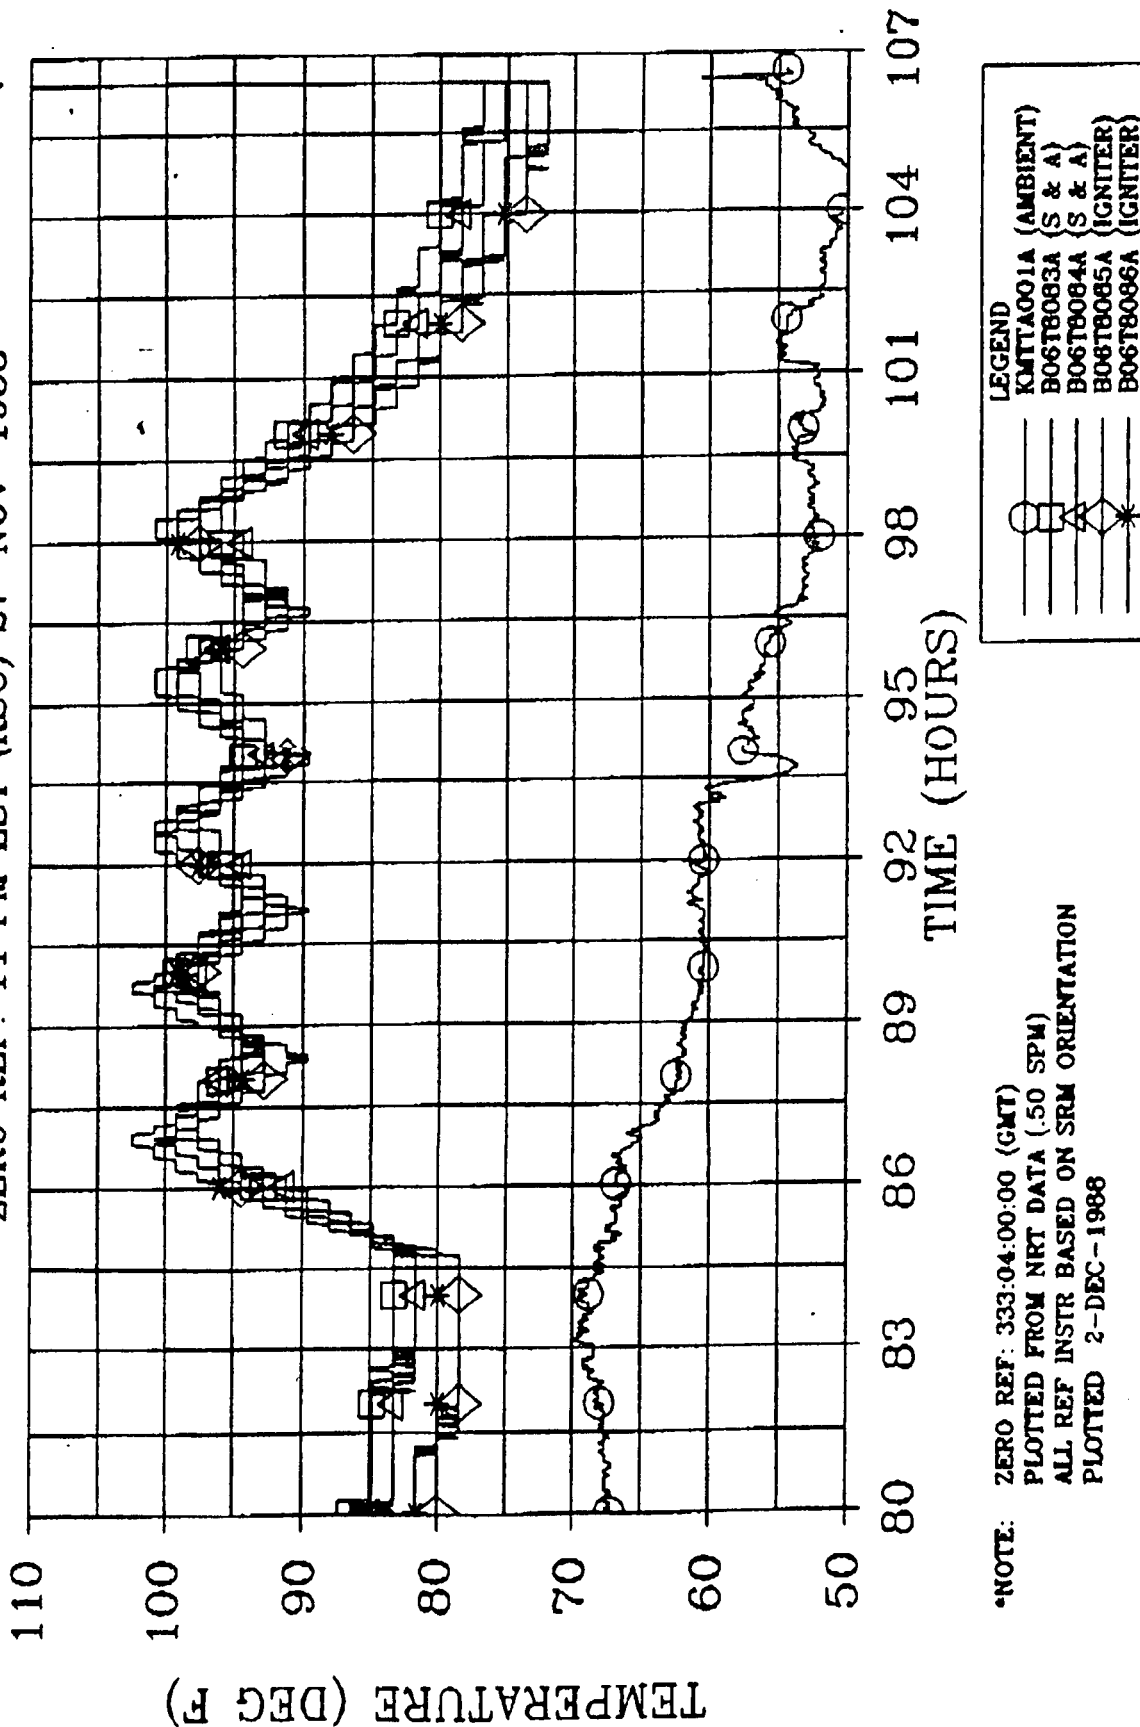
Figure 11

The igniter heater installation on each motor was intact and secure. Both heaters were charred in two places where instrumentation wiring was improperly run between the heater and igniter adapter. The adjacent cork and painted igniter adapter also showed evidence of heat effect. Figures 10 and 11 are the plots of the temperature at the igniter adapter. Tables 15 and 16 are the evaluation checkoff worksheets for the igniter heater installation. Tables 17 and 18 are the evaluation checkoff worksheets for the igniter heater components.
